Cape Lookout National Seashore  
**Cape Lookout Life-Saving Station**

# **HISTORIC STRUCTURE REPORT**

August 2003

2002  
Historic Structure Report  
Life- Saving Station  
Cape Lookout National Seashore  
Cape Lookout Village  
LCS#: 091835

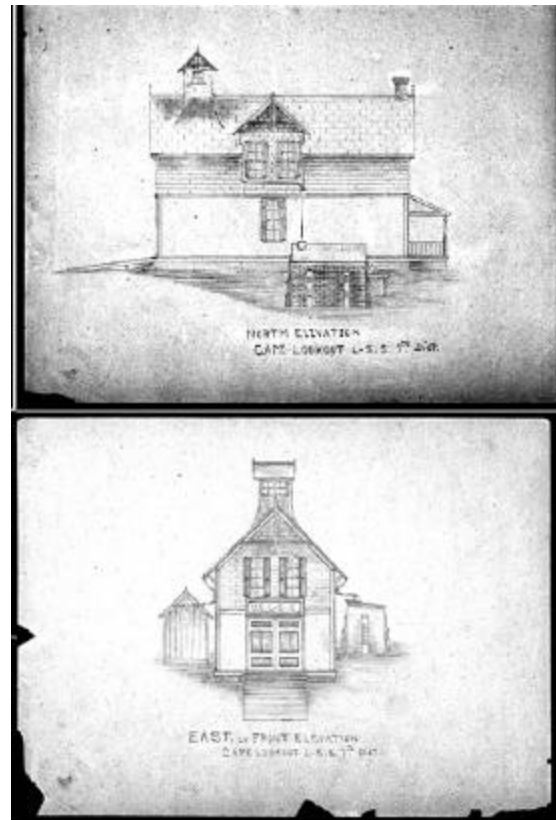
**Figure 24** Elevations of Life-Saving Station, 1905. (U.S. Coast Guard)

In 1905, elevations were drawn of the station, providing the first documentation for the back porch. These elevations also show a continuous brick foundation, which was probably installed around that time. It was certainly present by 1915 (see Figure 8).

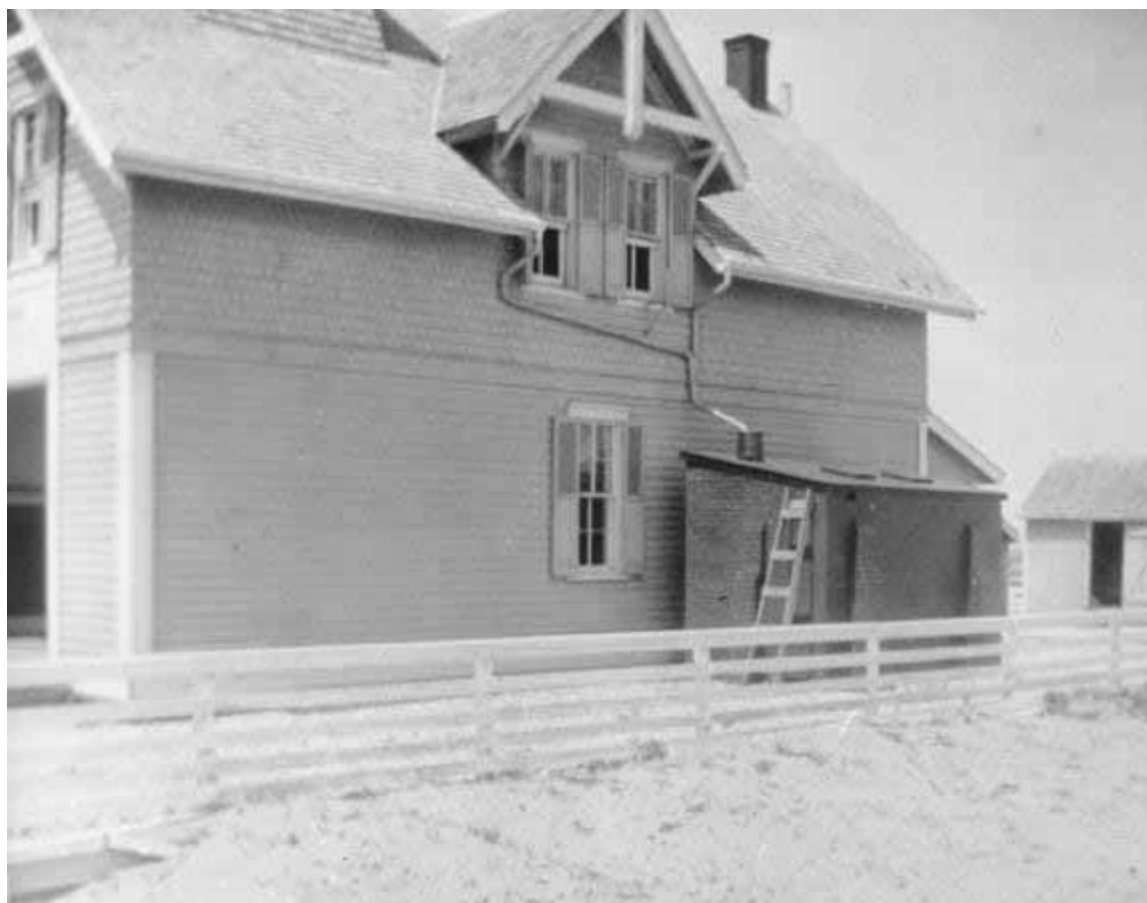
**Figure 25** View of live-saving station c. 1915, showing one of two cisterns that served the building.<sup>38</sup> (CALO Coll, USLSS#2)

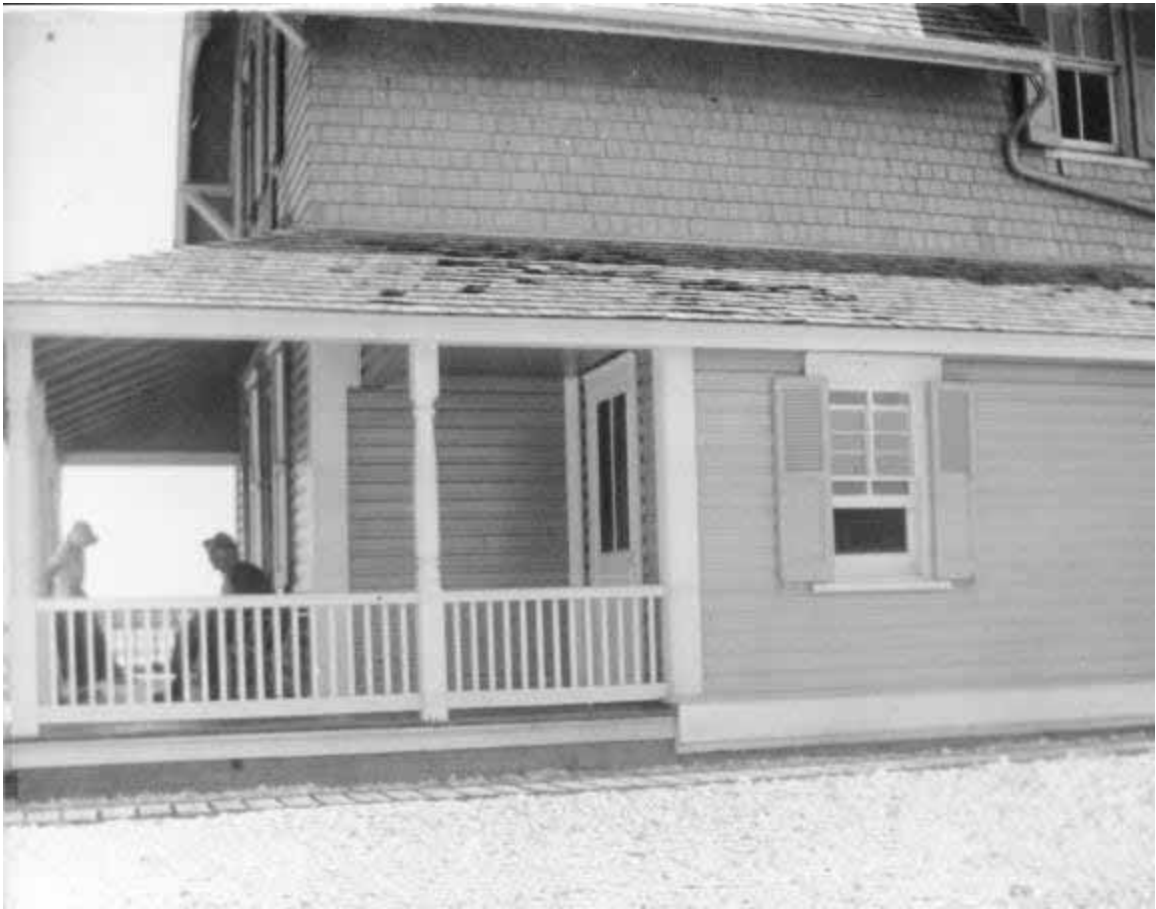
**Figure 26** View of back porch of life-saving station, c. 1915. (CALO Coll.)

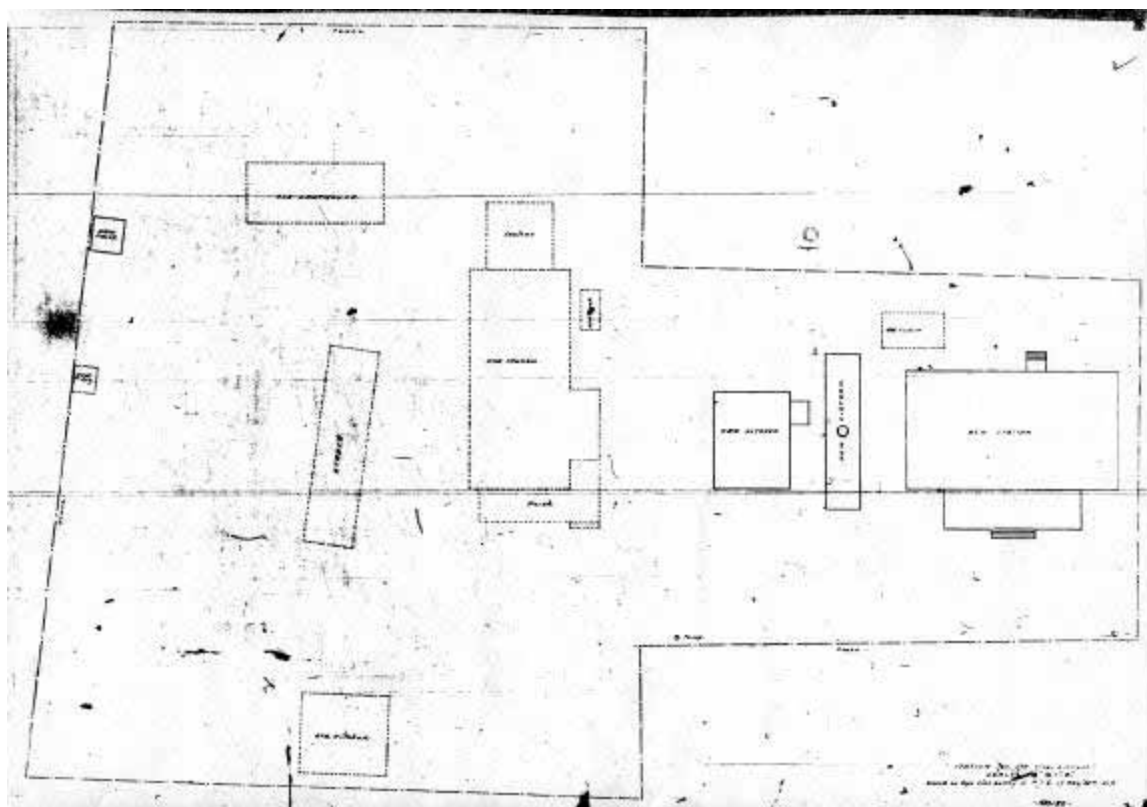
**Figure 27** Plan of Cape Lookout Coast Guard Station, May 1917, with new building at right on site of old life-saving station, which is shown on its new site at center. (U. S. Coast Guard)

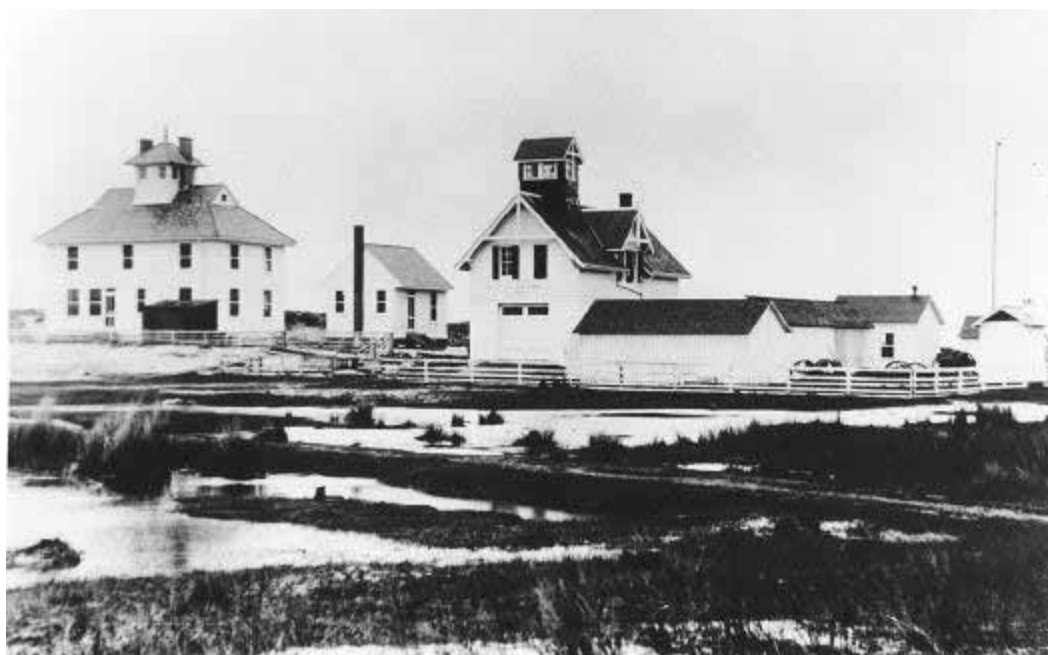
**Figure 28** View to south of Cape Lookout Coast Guard Station #190, shortly after the new station was completed in 1917. (CALO Coll. D-57)

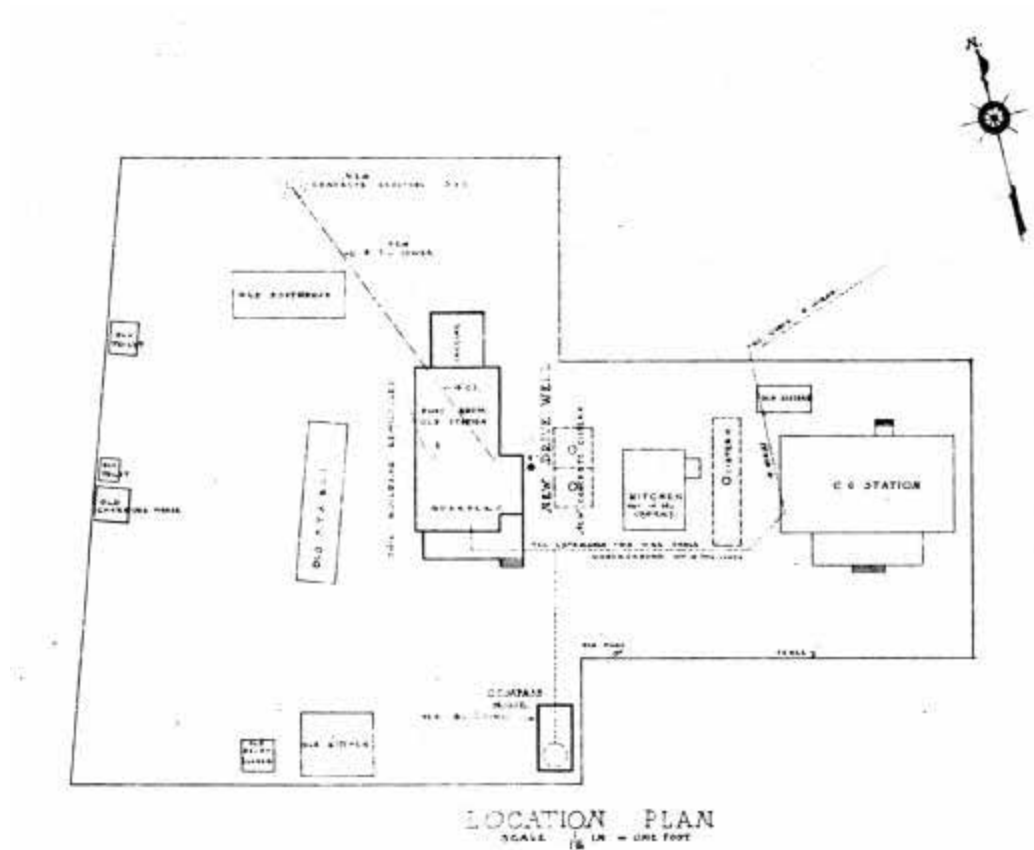
**Figure 29** "Location Plan" for Cape Lookout Coast Guard Station, August 1920. The old stable and boathouse on the west side of the site would be removed that fall. (U.S. Coast Guard)

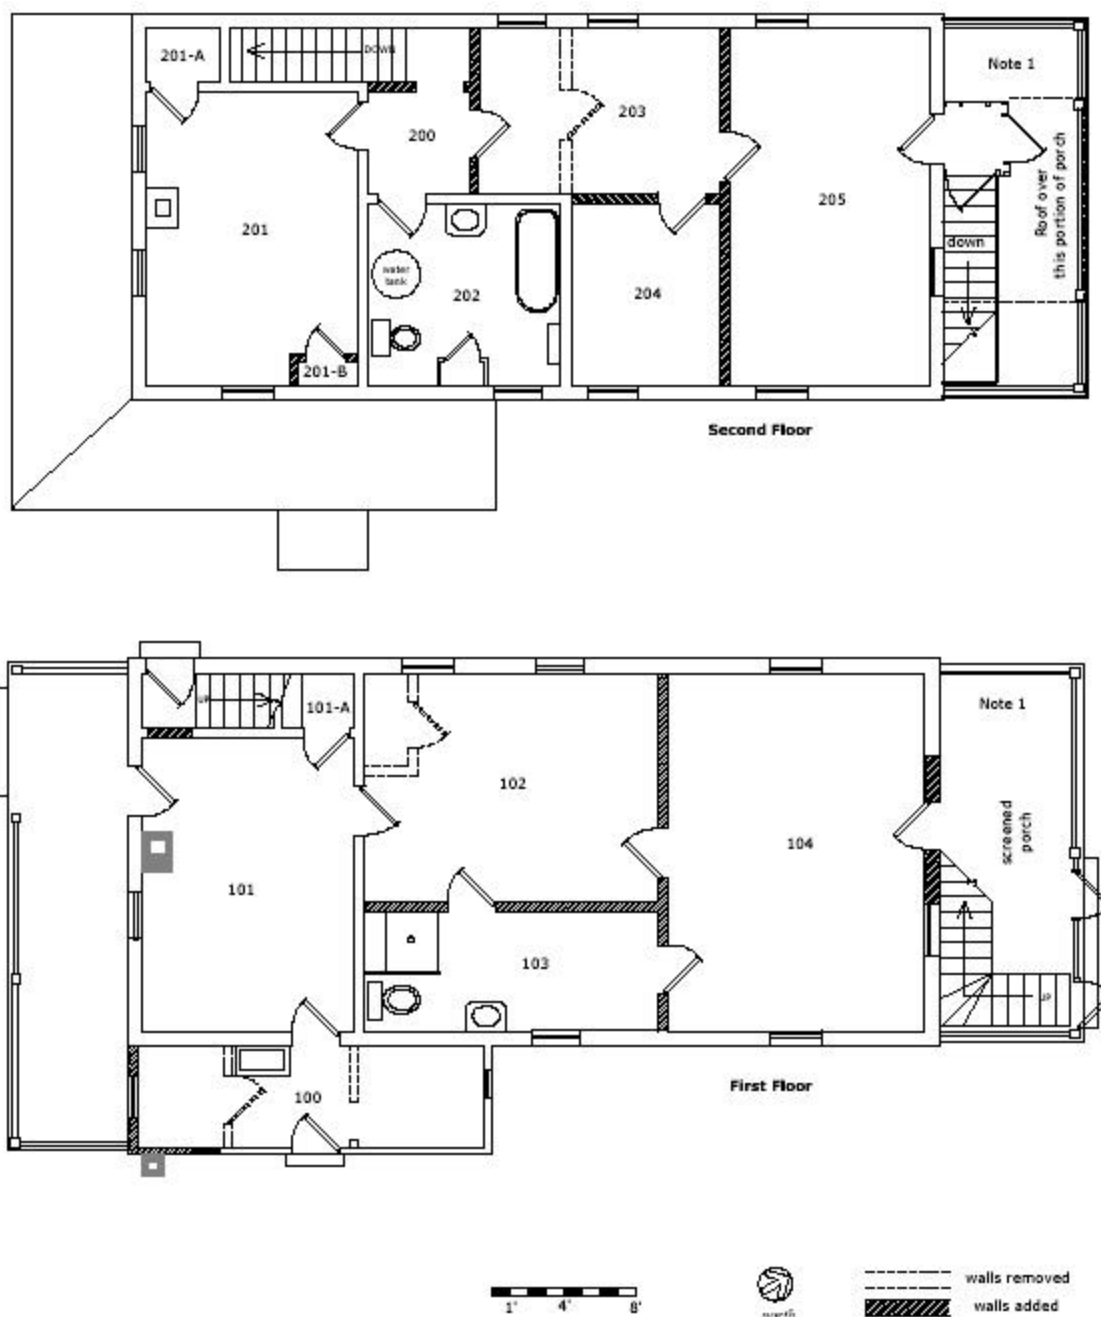
**Figure 30** Plan of old life-saving station, depicting changes that occurred between the world wars, most of them in the early 1920s. Room 103 may not have been converted into a bathroom until the late 1930s. (T. Jones, NPS-SERO-CR, 2003)

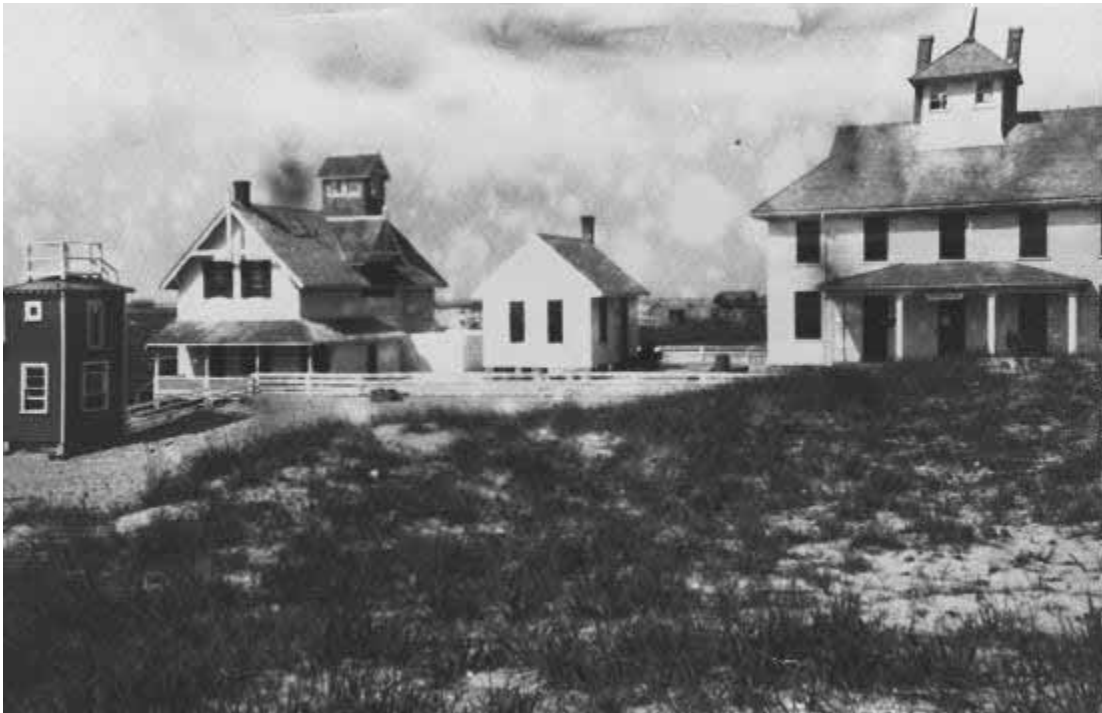
**Figure 31** View north of Cape Lookout Coast Guard Station, 1920. The new compass station, or “radio shack,” is at left, and the new concrete cistern is visible between the kitchen at center and the old life-saving station. (CALO Coll. D-52)

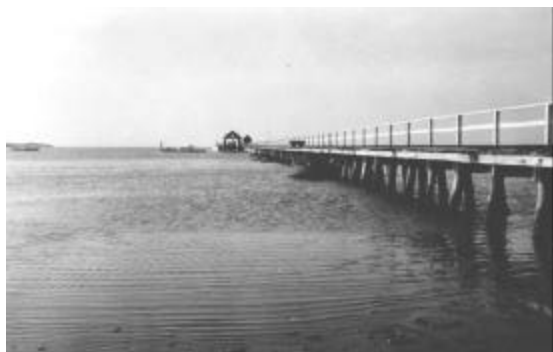
**Figure 32** View of the “dock in the hook” in 1943, and the boat house that replaced the original boat house that was torn down in 1916. (CALO-Coll.)

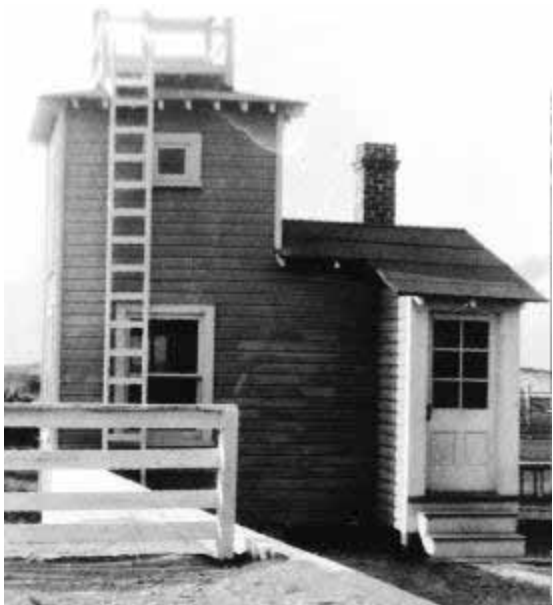
**Figure 33** View of 1919 “Radio Shack” during World War II. The concrete retaining wall seen here remains on the site. (CALO Coll. D-20)

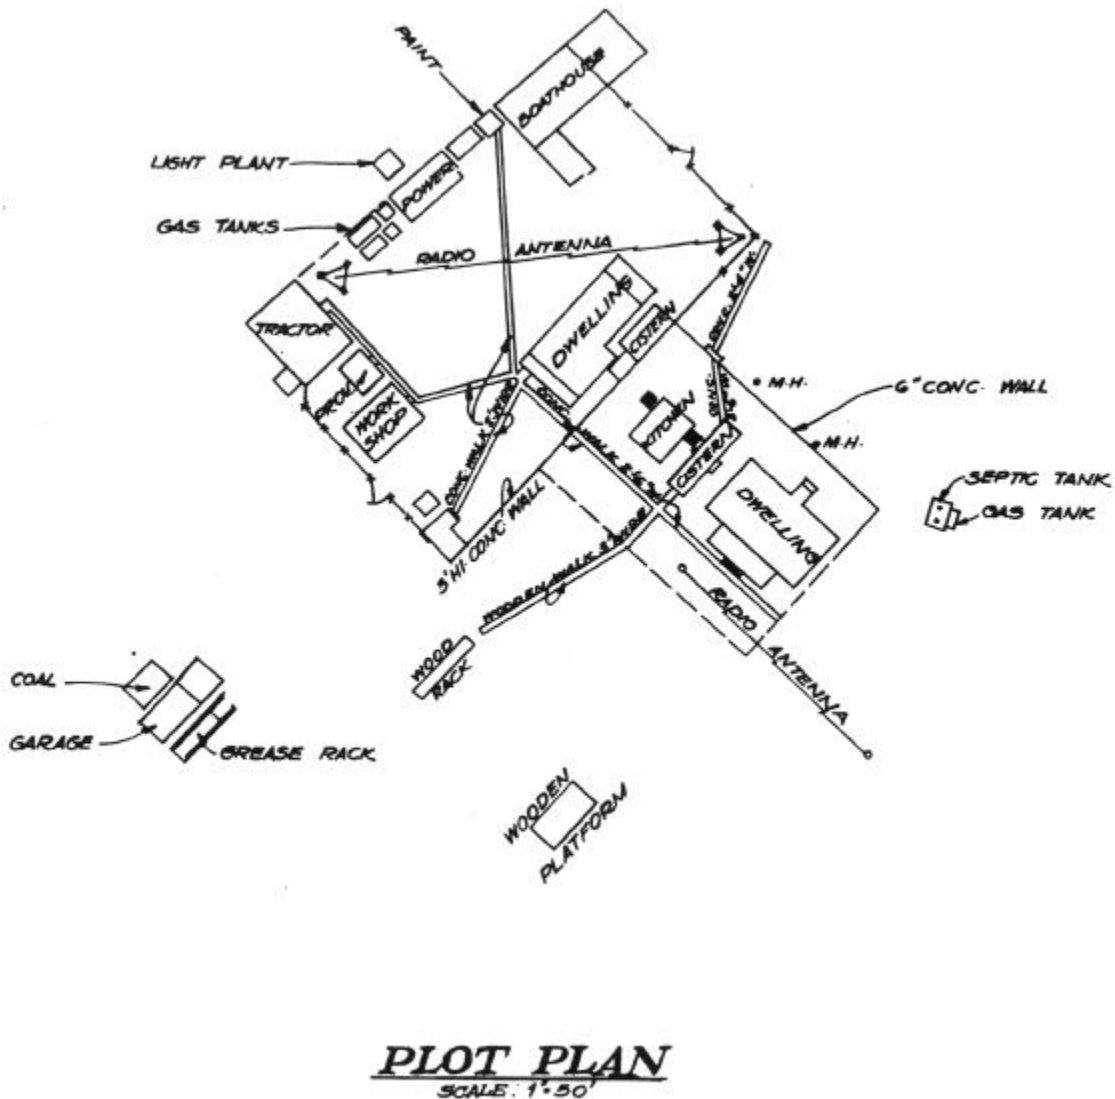
**Figure 34** Plot plan of Cape Lookout Coast Guard Station, August 1934. (Coast Guard Coll.)

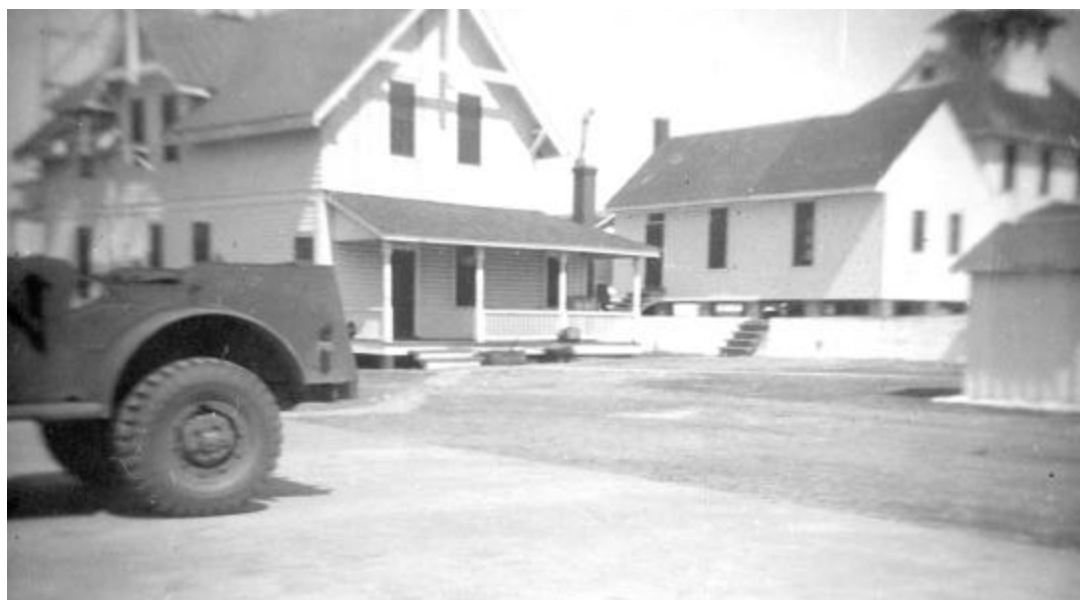
**Figure 35** View of Coast Guard Station and old life-saving station, 1943. (CALO Coll. Siff-02)

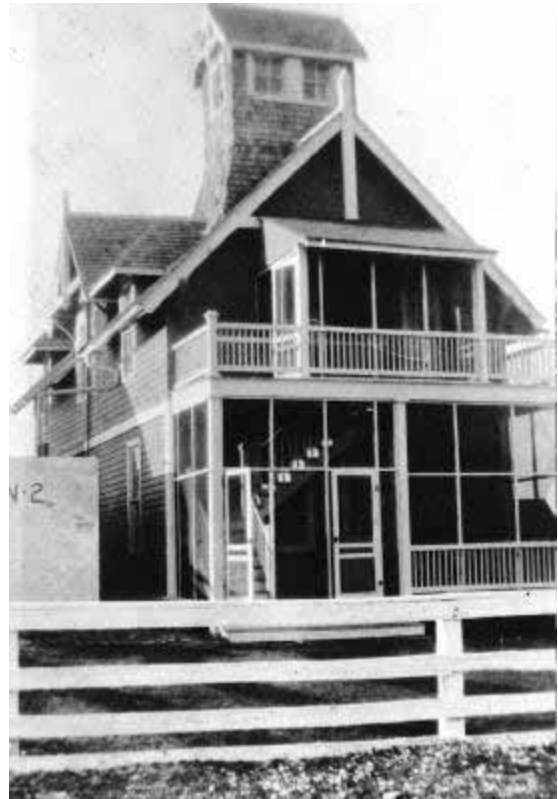
**Figure 36** View to south of old life-saving station, 1940, showing porches and dormers added in the 1920s. (CALO Coll. D-21)

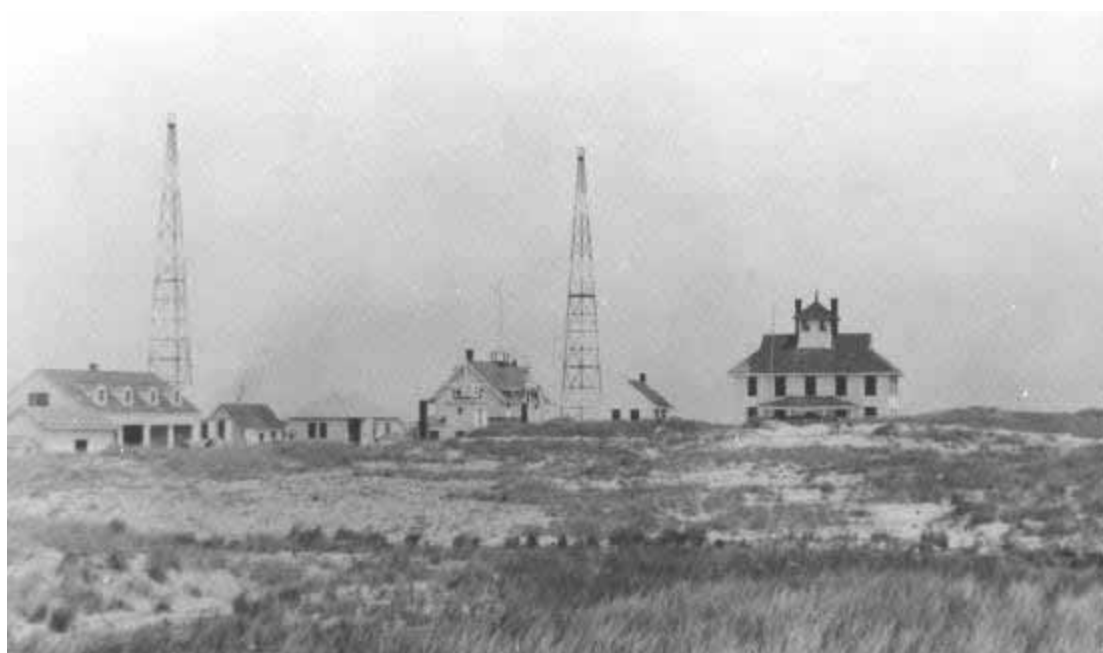
**Figure 37** View to north of Cape Lookout Coast Guard Station in 1941. The new maintenance building is visible at left. (CALO Coll. D-55)

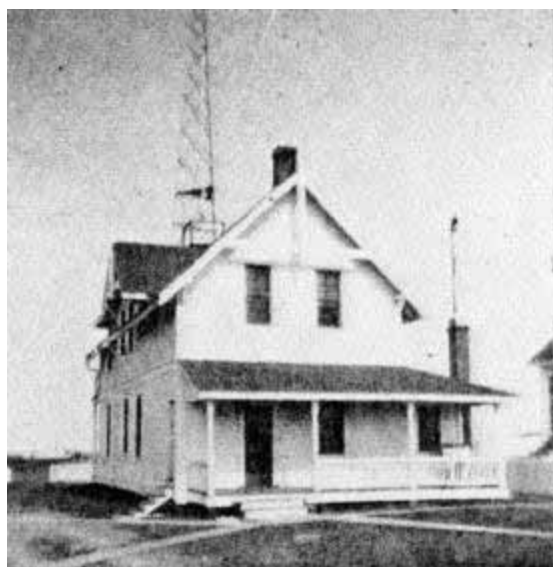
**Figure 38** View of life-saving station, c. 1941. (CALO Coll., O-Boyle Coll.)

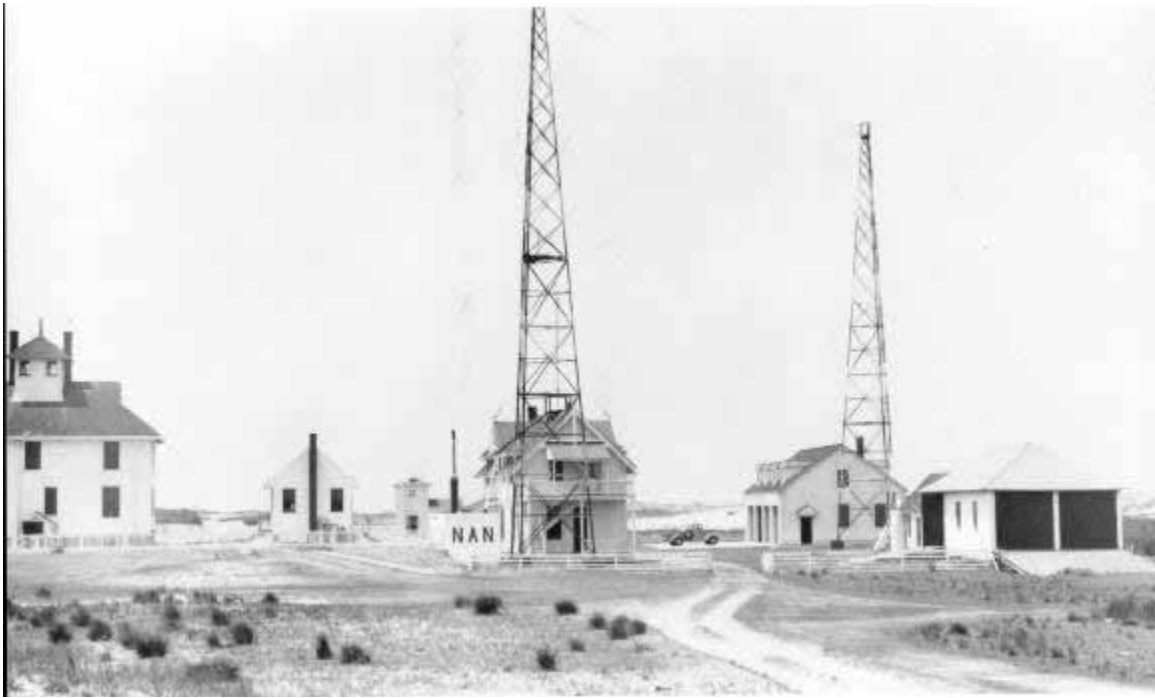
**Figure 39** Undated photograph of Cape Lookout Coast Guard Station at the end of World War II. (CALO Coll.)

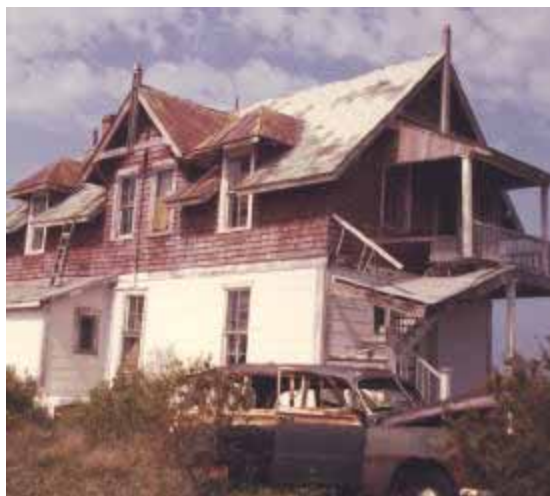
**Figure 40** View of old life-saving station, c. 1969. (CALO Coll.)

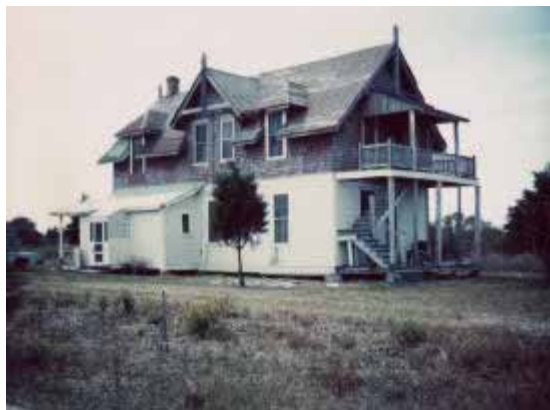
**Figure 41** View of old life-saving station in 1978. (CALO Coll.)

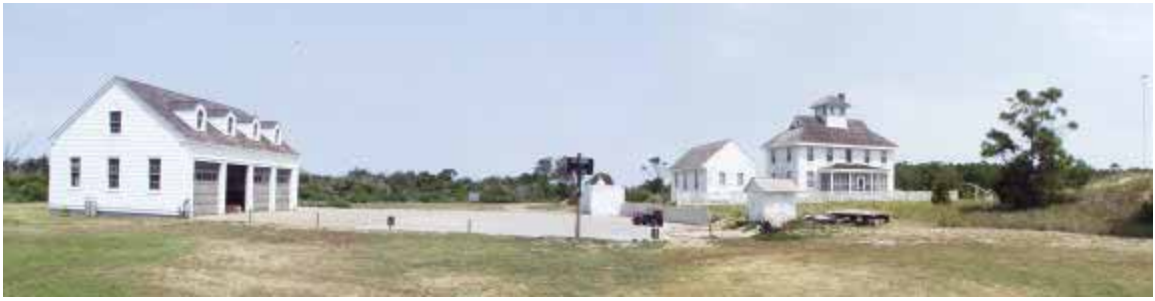
**Figure 42** View of Coast Guard Station in 2003. (NPS-SERO-CR, 2003)

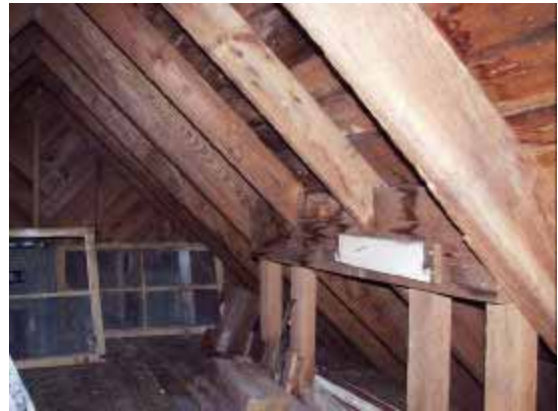
**Figure 5** View of roof framing at northeastern end of the building. Rafter at upper right is original; the next two, which are smaller, infill the original opening for the lookout. (NPS-SERO-CRS, 2002)

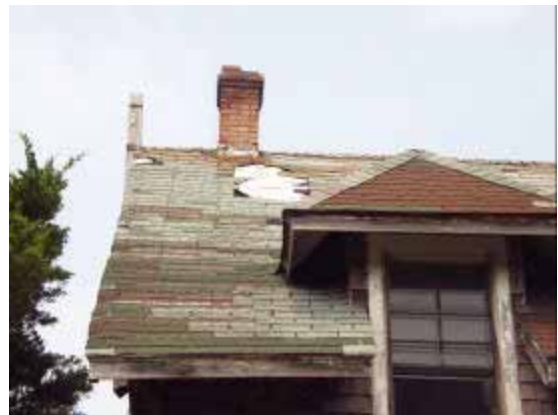
were installed over the metal roofing, except on the dormers. The entire roof, including the dormers, was overlaid with the present, three-tab, asphalt shingles in a variety of colors around 1970. These shingles are missing in several areas and in poor condition over the entire surface of the roof.

**Figure 6** View of existing roofing. White "hurricane" asphalt shingles installed in early 1950s are exposed just below the chimney. (NPS-SERO-CRS, 2002)

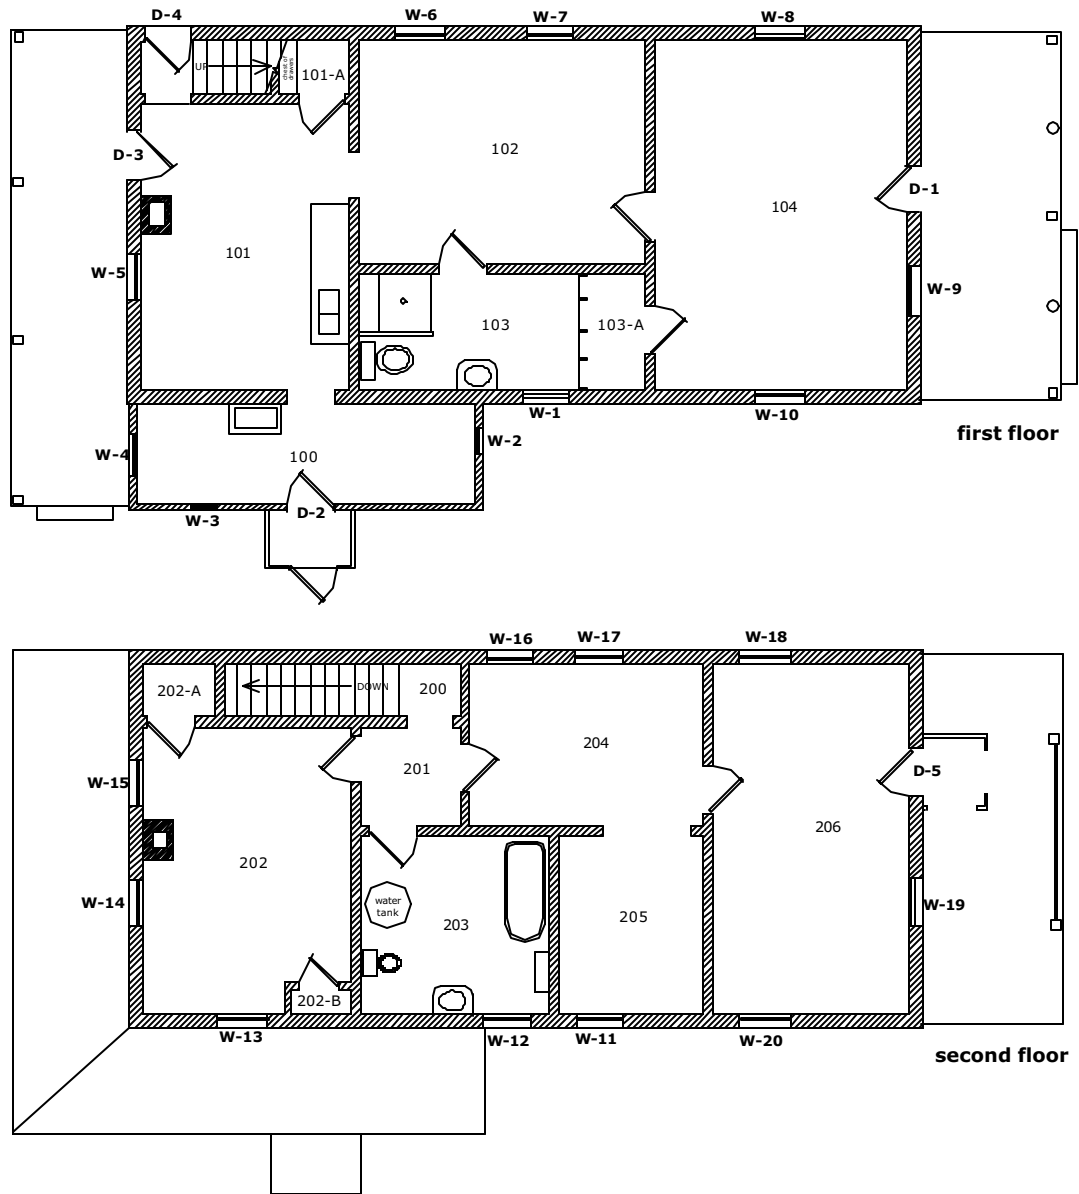
*W- 3:* Opening created when chimney was removed in 1958; opening 1'- 6" by 2'- 11"; fixed, two- light sash; typical sill, casing, drip cap, and wood- framed screen; poor condition.

*W- 4:* Opening is part of enclosure of original entry porch, c. 1920; opening 2'- 4" by 4'- 2", double- hung, wood sash, 4/4, probably relocated from east wall at D- 2; poor condition.

**Figure 7** .Plan of windows and doors. (T. Jones, NPS-SERO-CRS, 2002)

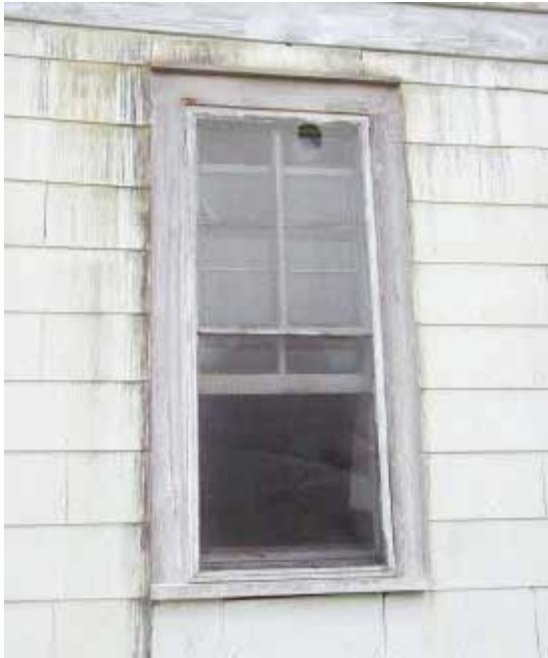
**Figure 9** View of window on western side of house, typical of original opening and detail. (NPS-SERO-CRS, 2002)

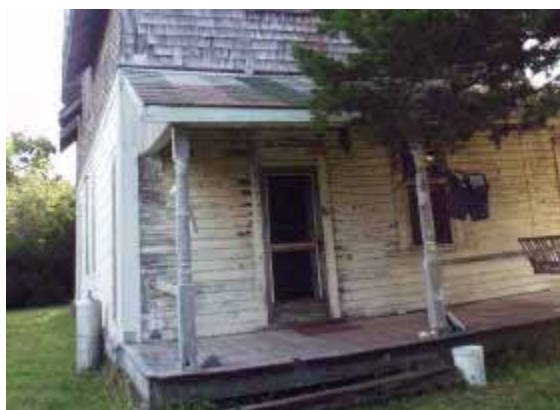
**Figure 14** View of back or south porch, added before 1905. The door was not present until the renovations in the 1920s. (NPS-SERO-CRS, 2002)

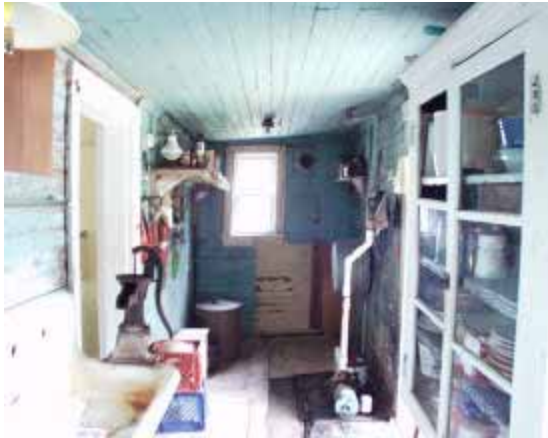
*Floors:* Measuring about 5'-7" by 19'-4", the wooden floor in this room is covered with modern vinyl floor coverings but appears to be in very poor condition. Where the wall was

removed separating the pantry and the original entry hall, the floor is collapsing.

**Figure 20** View to north in Room 100, showing location of original pantry. (NPS-SERO-CRS, 2002)

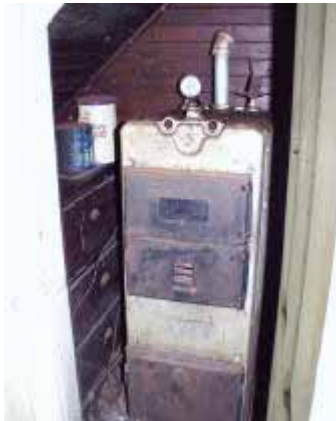
**Figure 24** View of original closet on west side of kitchen and defunct boiler now stored in the space. (NPS-SERO-CRS, 2002)

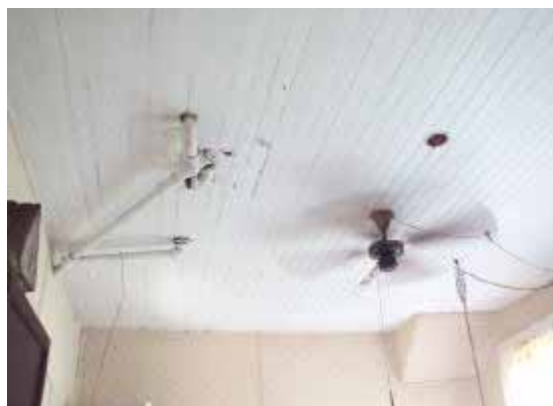
**Figure 27** View of ceiling in Room 102, showing cast-iron waste lines (c. 1920) from upstairs bathroom. (NPS-SERO-CRS, 2002)

Cast-iron waste and vent lines from the bathroom in Room 202 are exposed on the ceiling along the east side of the room. Because the upstairs sink was relocated, only the vent stacks are still in use. Other holes in the ceiling above the windows indicate the location of risers for the building's historic heating system.

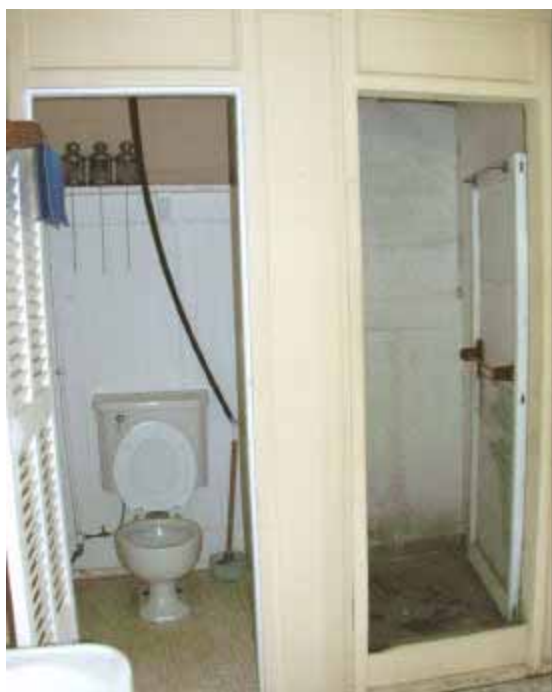
**Figure 29** View of toilet and shower in Room 103. Note original wainscot on rear wall of toilet room. (NPS-SERO-CRS, 2002)

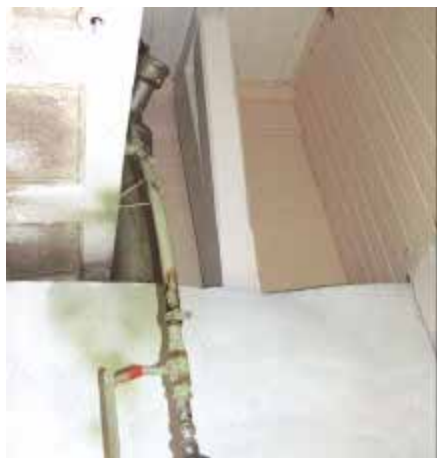
**Figure 30** View of large bracket behind and above shower, installed to support water tank at second floor. Note original cornice on rear wall. (NPS-SERO-CRS, 2002)

*Miscellaneous:* Next to the toilet is a large, cast-iron water tank set on wooden blocks and supported from below by a large bracket mounted against the ceiling below in Room 103. It was installed after 1969 to replace the original 1920s tank, which was moved but remains in the room after an unsuccessful attempt to saw it up and remove it.

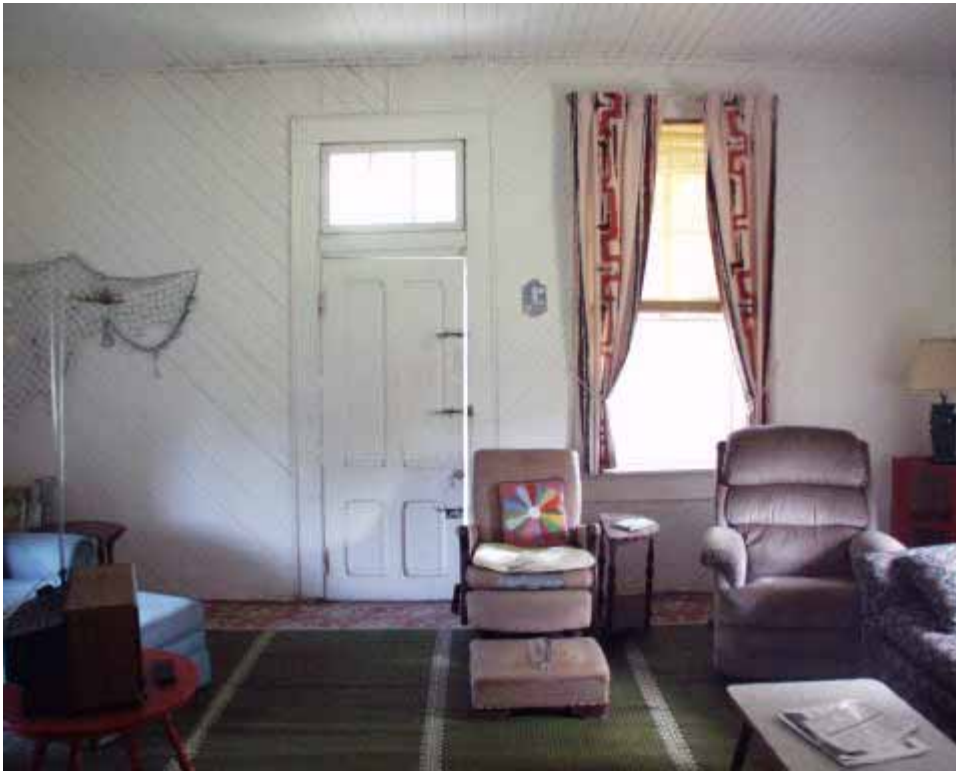
**Figure 31** View north in Room 104. Two pairs of large doors originally opened into the boat room at this location. (NPS-SERO-CRS, 2002)

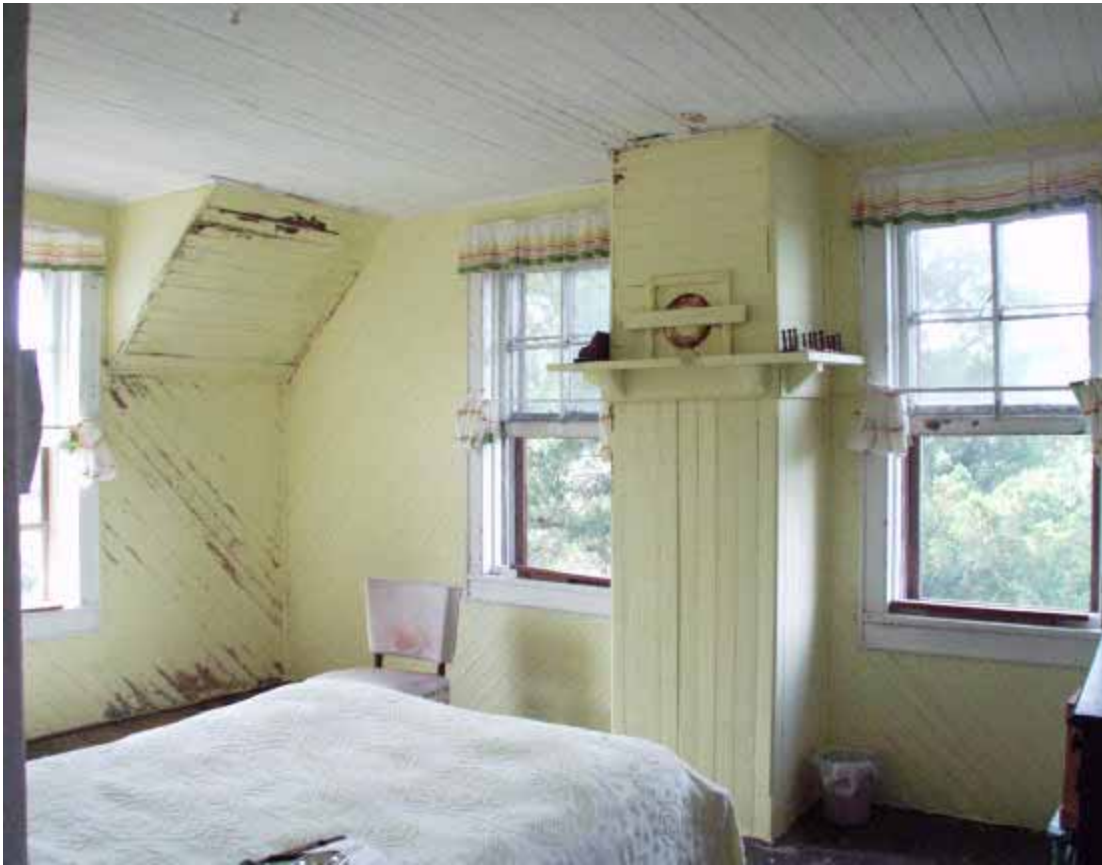
**Figure 33** View to south in old keeper's room (Room 202). Note original paneling and plate rail around chimney rising between the two windows on the south wall. (NPS-SERO-CRS, 2002)

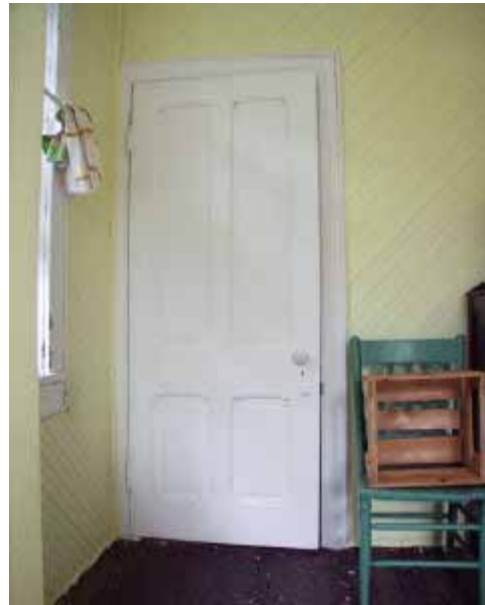
**Figure 35** View of original door in Room 202, complete with original mortise lock and porcelain knob. (NPS-SERO-CRS, 2002)

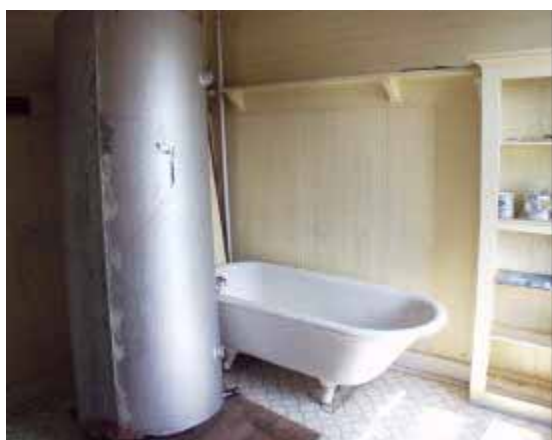
**Figure 38** View to north in Room 203, showing tub and original 1920s water tank. (NPS-SERO-CRS, 2002)

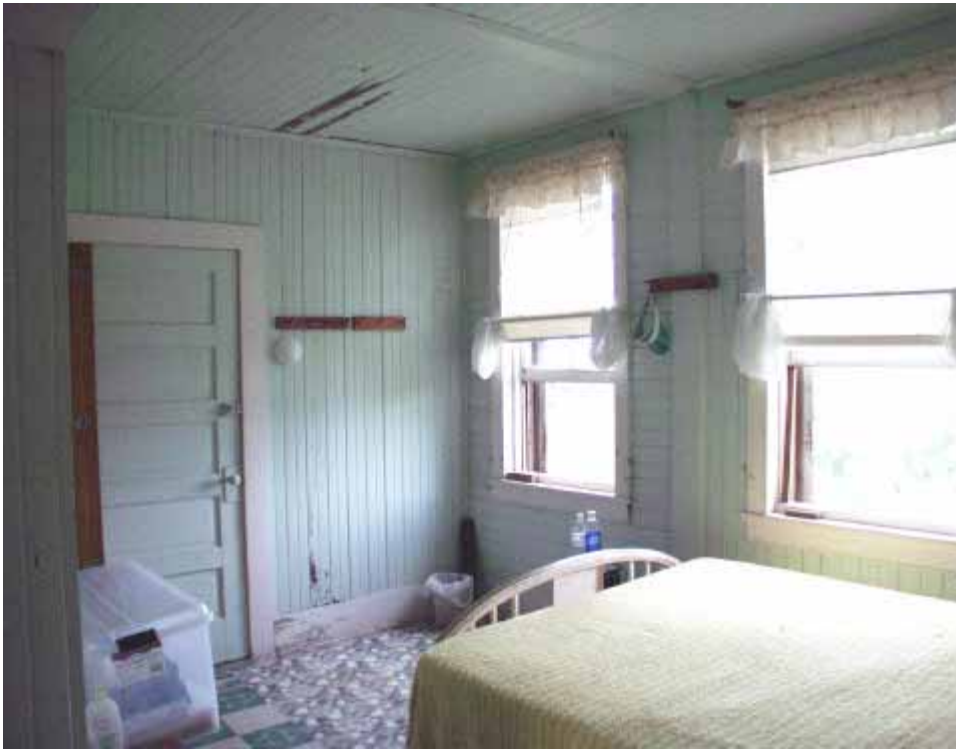
**Figure 39** View to west in Room 204. The wall that separated the original hall from the crews' quarters was located between the two windows. (NPS-SERO-CRS< 2002)

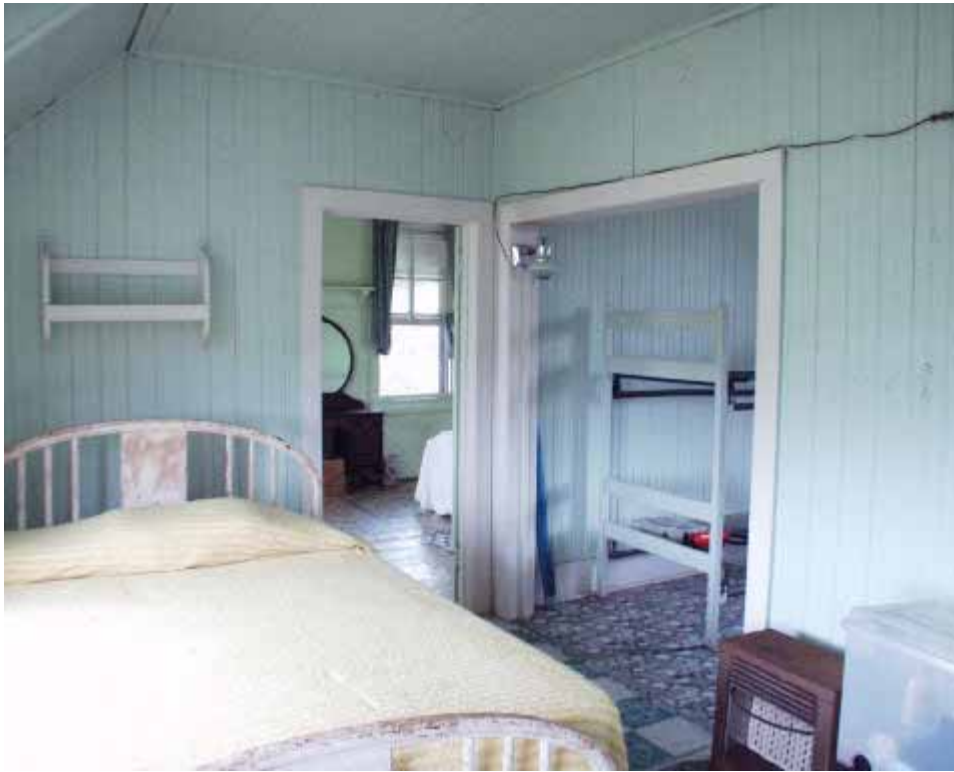
**Figure 40** View to northeast in Room 204. Large cased opening at right was created after the partitioning of the crews' quarters, probably after the building was moved. (NPS-SERO-CRS, 2002)

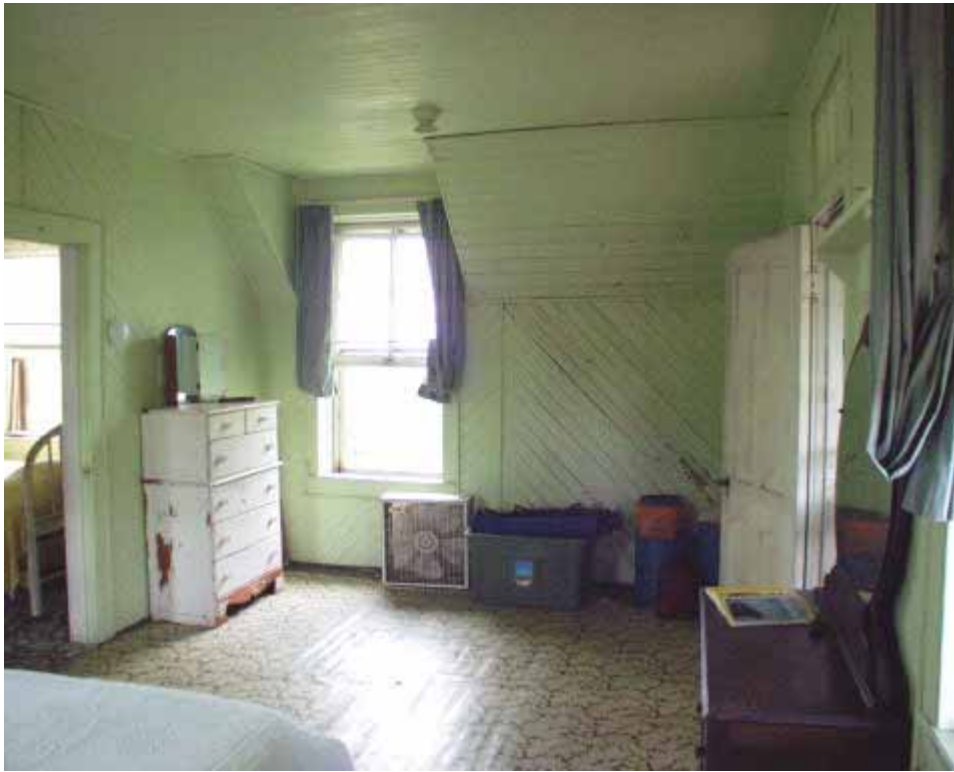
**Figure 42** View to west in Room 206, showing one of dormers added to second floor prior to World War II. (NPS-SERO-CRS, 2002)

*Windows and Doors:* The dormer windows on the southeast and northwest walls were added as part of the c. 1920 alterations to the building. On the northeast wall, the window is original, but the door to the porch replaced an original window at that location.

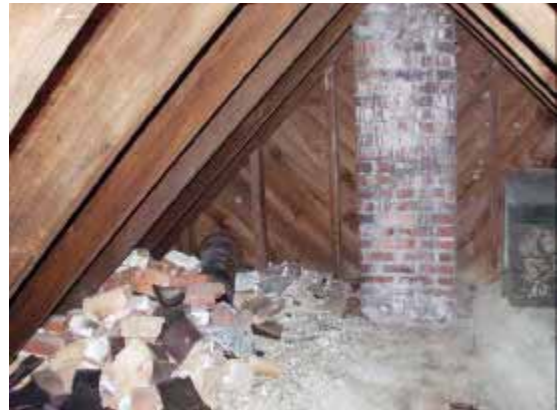
At the south end of the attic, a brick chimney rises through the center of the gable. Nearby in the south corner of the attic is a pile of brick rubble from the original chimney when it was rebuilt in 1916.

**Figure 44** View to south in attic showing chimney stack and unidentified brick rubble. (NPS-SERO-CRS, 2002)
